REL RICHLAND ENGINEERING LIMITED
MANSFIELD, OHIO

SURVEY OF MANSFIELD JOINT VENTURE
PROPERTY AT RICHLAND MALL
BOUNDARY DRAWING
ENCROACHMENT DETAILS
VILLAGE OF ONTARIO
COUNTY OF RICHLAND
STATE OF OHIO

2 / 4

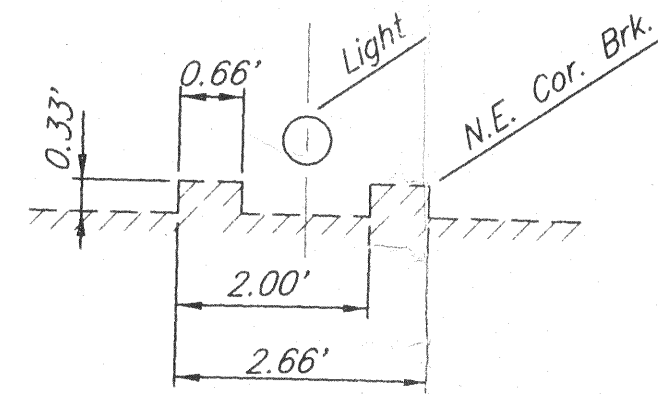
TYPICAL BRICK PROJECTION
ALONG NORTH PROPERTY LINE

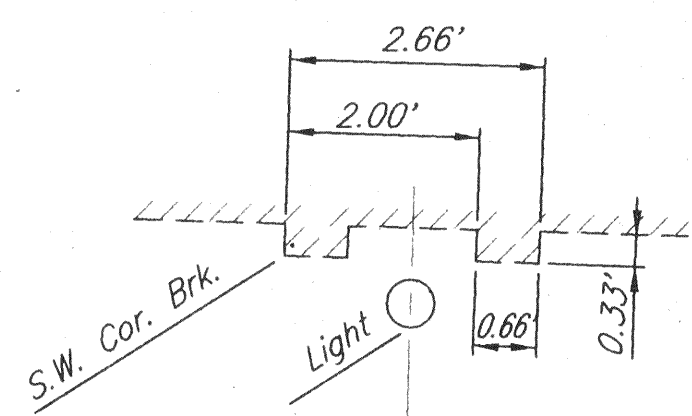
TYPICAL BRICK PROJECTION
ALONG SOUTH PROPERTY LINE

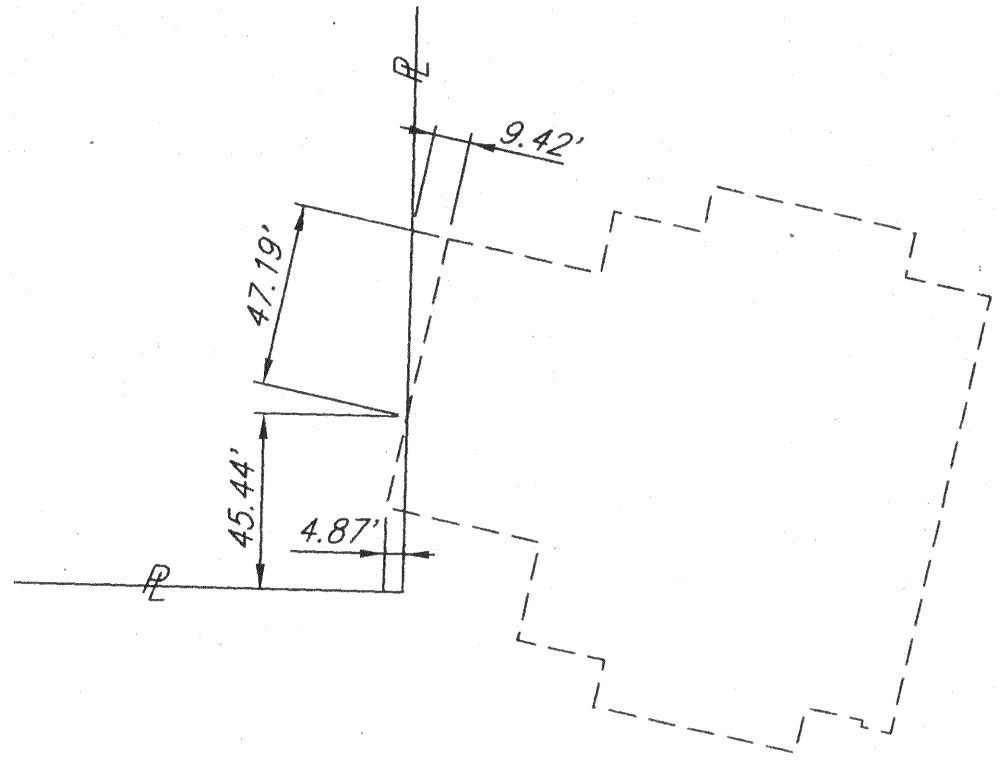
ENCROACHMENT DETAIL C
SEARS AUTO CENTER BLDG.

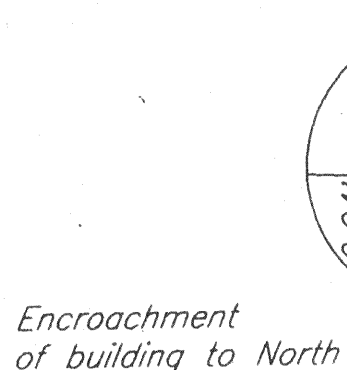
Encroachment of building to North

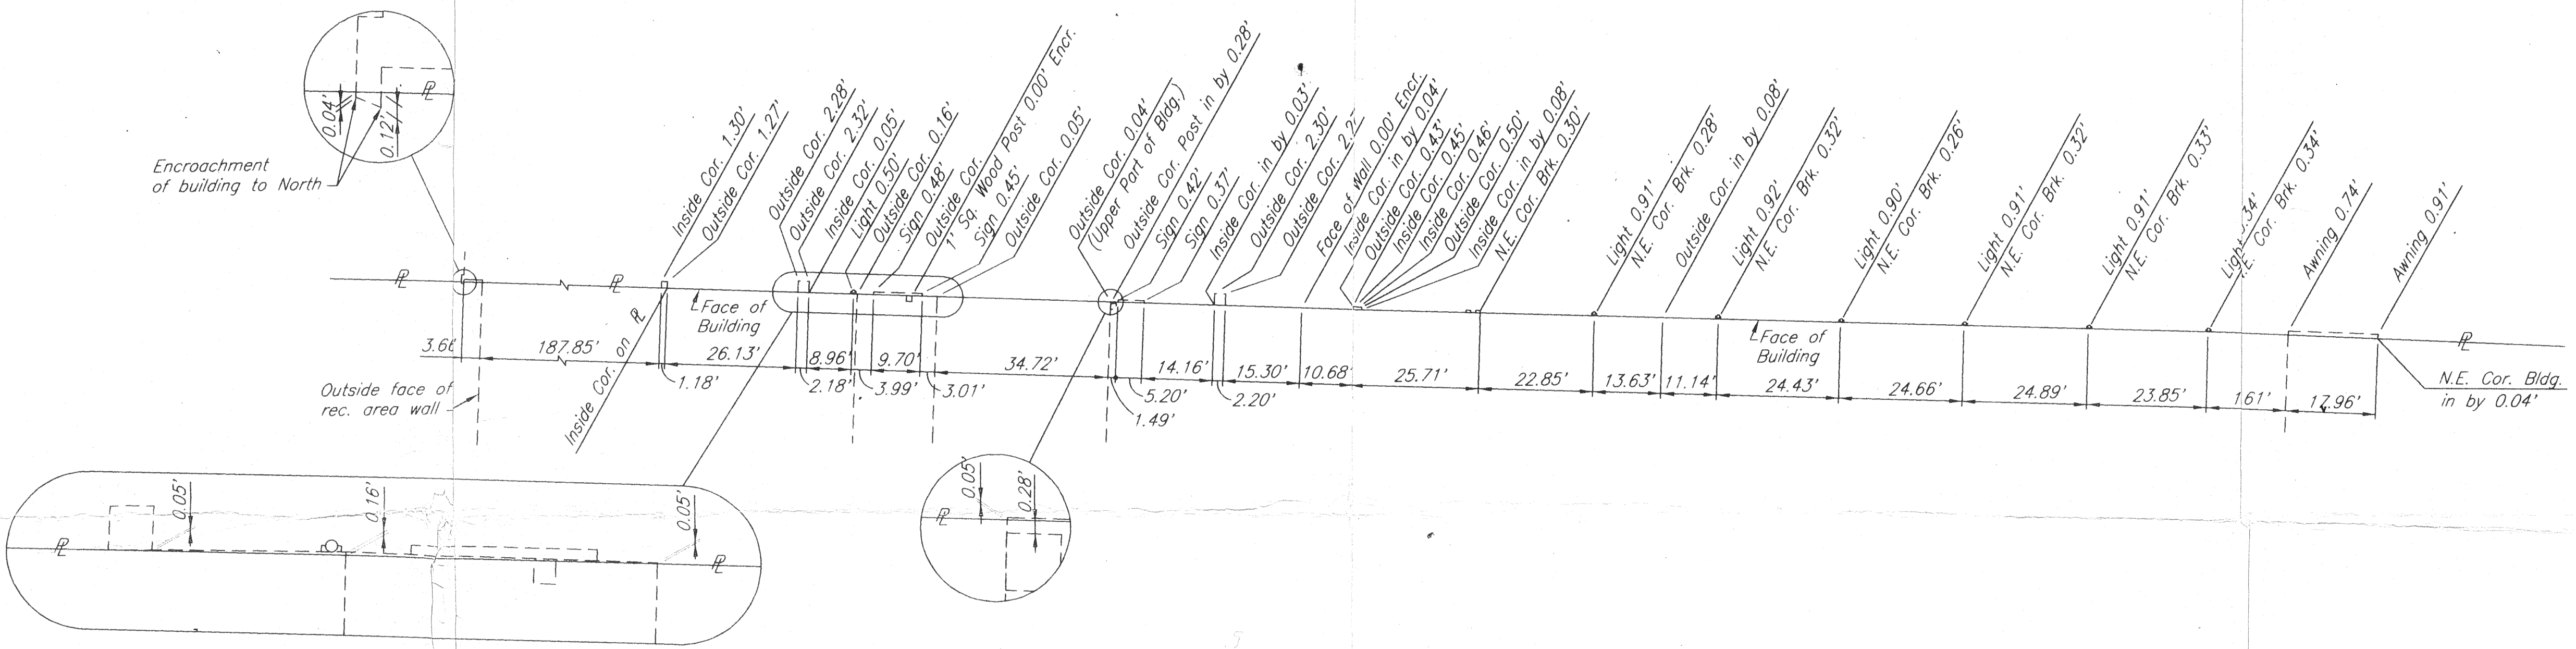
ENCROACHMENT DETAIL A
ALONG NORTH PROPERTY LINE

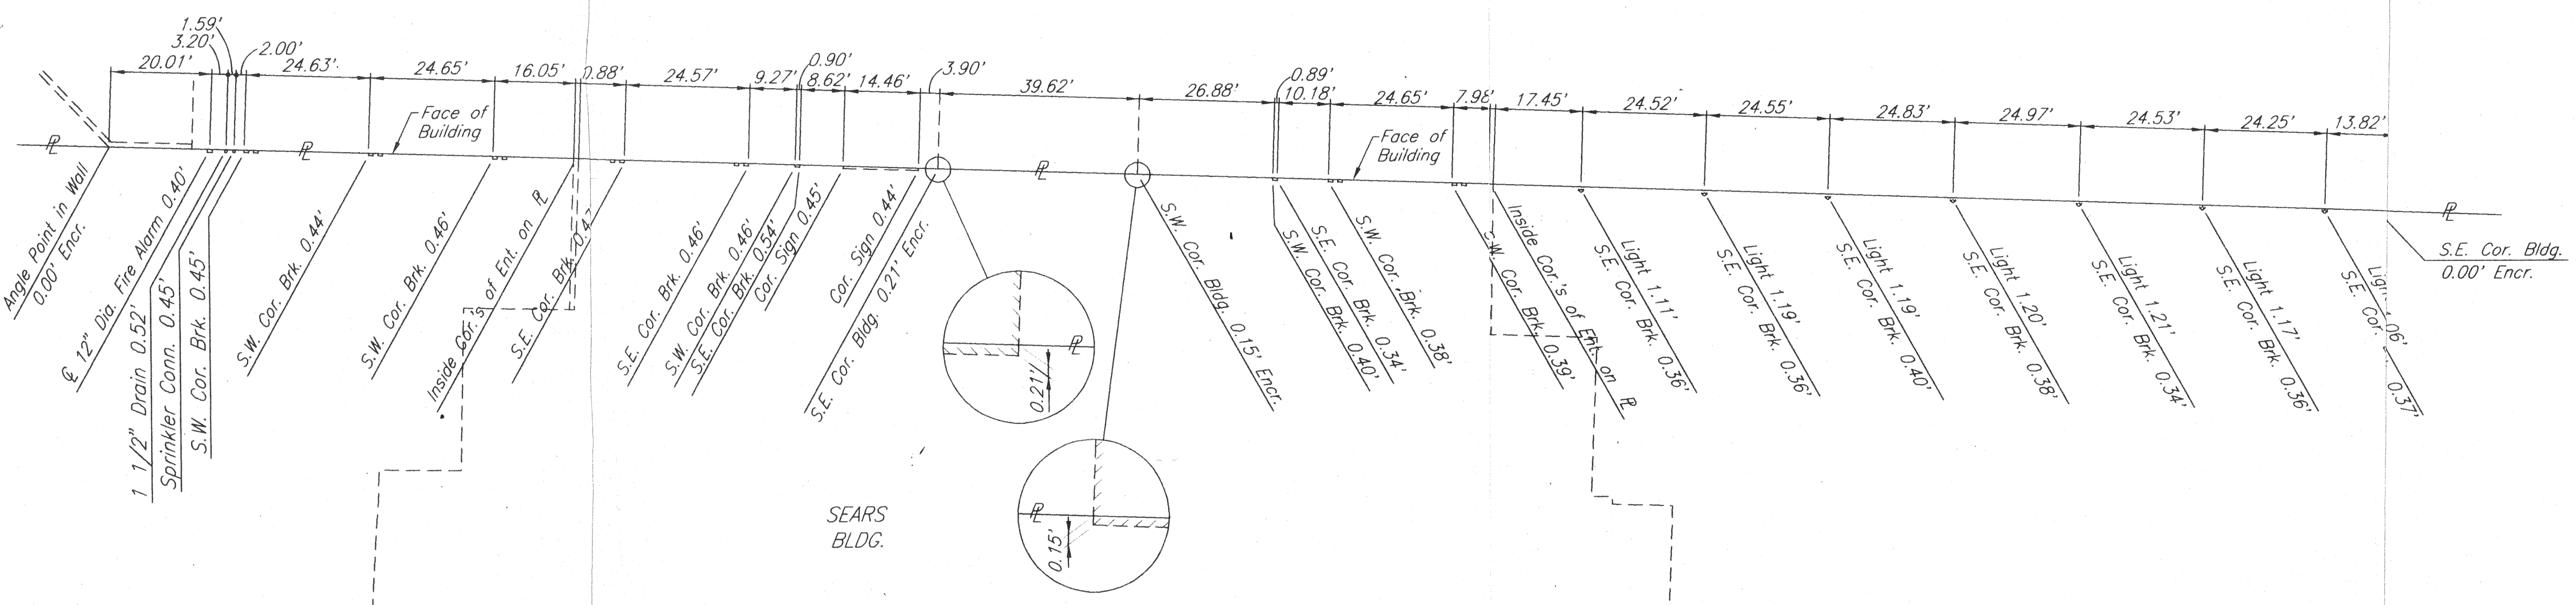
ENCROACHMENT DETAIL B
ALONG SOUTH PROPERTY LINE
