PHILLIP MARCUS  
Consulting Engineer and Surveyor  
191 PARK AVENUE WEST  
MANSFIELD, OHIO 44902

LEGAL DESCRIPTION: E. THRUSH PROPERTY

Situated in the Northwest quarter of Section 7, T.21, R.17 of Worthington Township, Richland County, Ohio and being further described as follows.

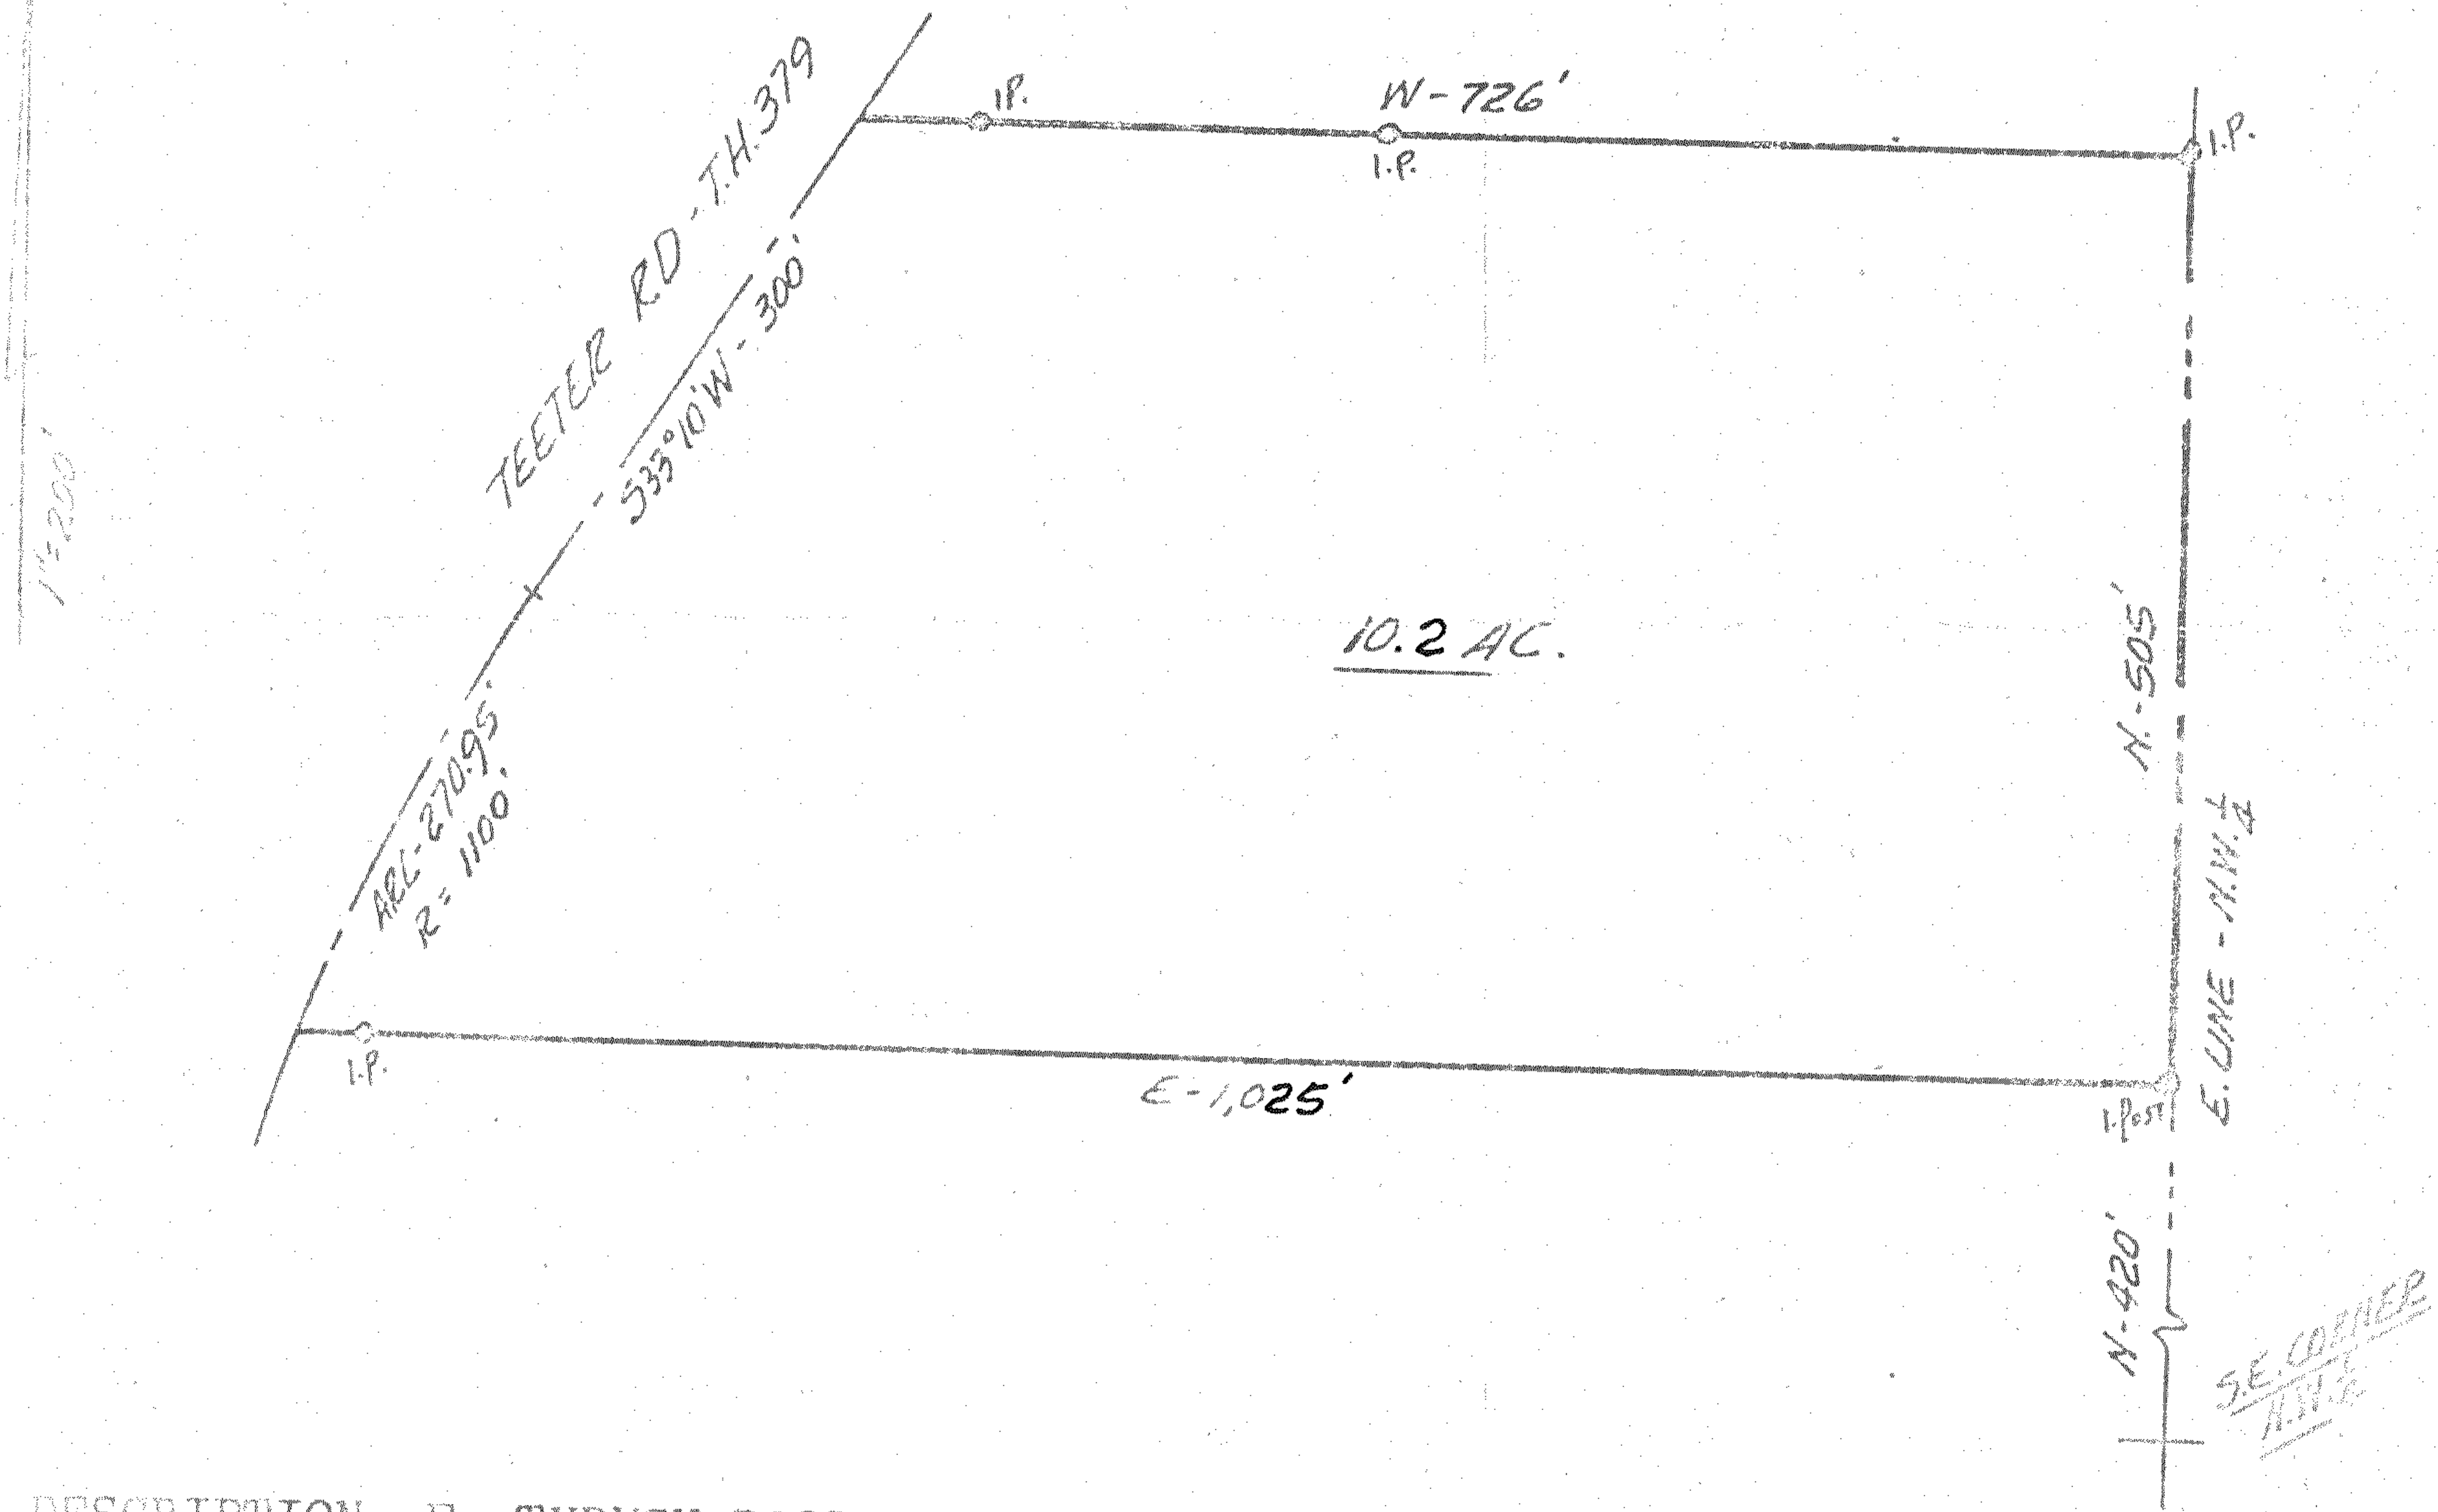
Commencing at the Southeast corner of said Northwest quarter; thence North, along the East line of the quarter, 420 feet to the true place of beginning.

Thence, continuing North, along the said East line of the quarter, 505 feet; thence West and parallel to the South line of the quarter, 726 feet to the centerline of Teeter Rd, T.H. 379; thence South 33°10' West, along said centerline, 300 feet; thence Southwesterly, along said centerline, on a curve to the left with a radius of 1,100 feet, 270.95 feet; thence East and parallel to the South line of the quarter, 1,025 feet to the place of beginning.

Containing 10.2 acres of land, more or less, and being subject to all legal highways and easements of record.....
