ROGER THRUSH PROPERTY
SECTION 7 - WORTHINGTON TWP.
RICHLAND COUNTY, OHIO

LEGAL DESCRIPTION: 6.0 ACRES

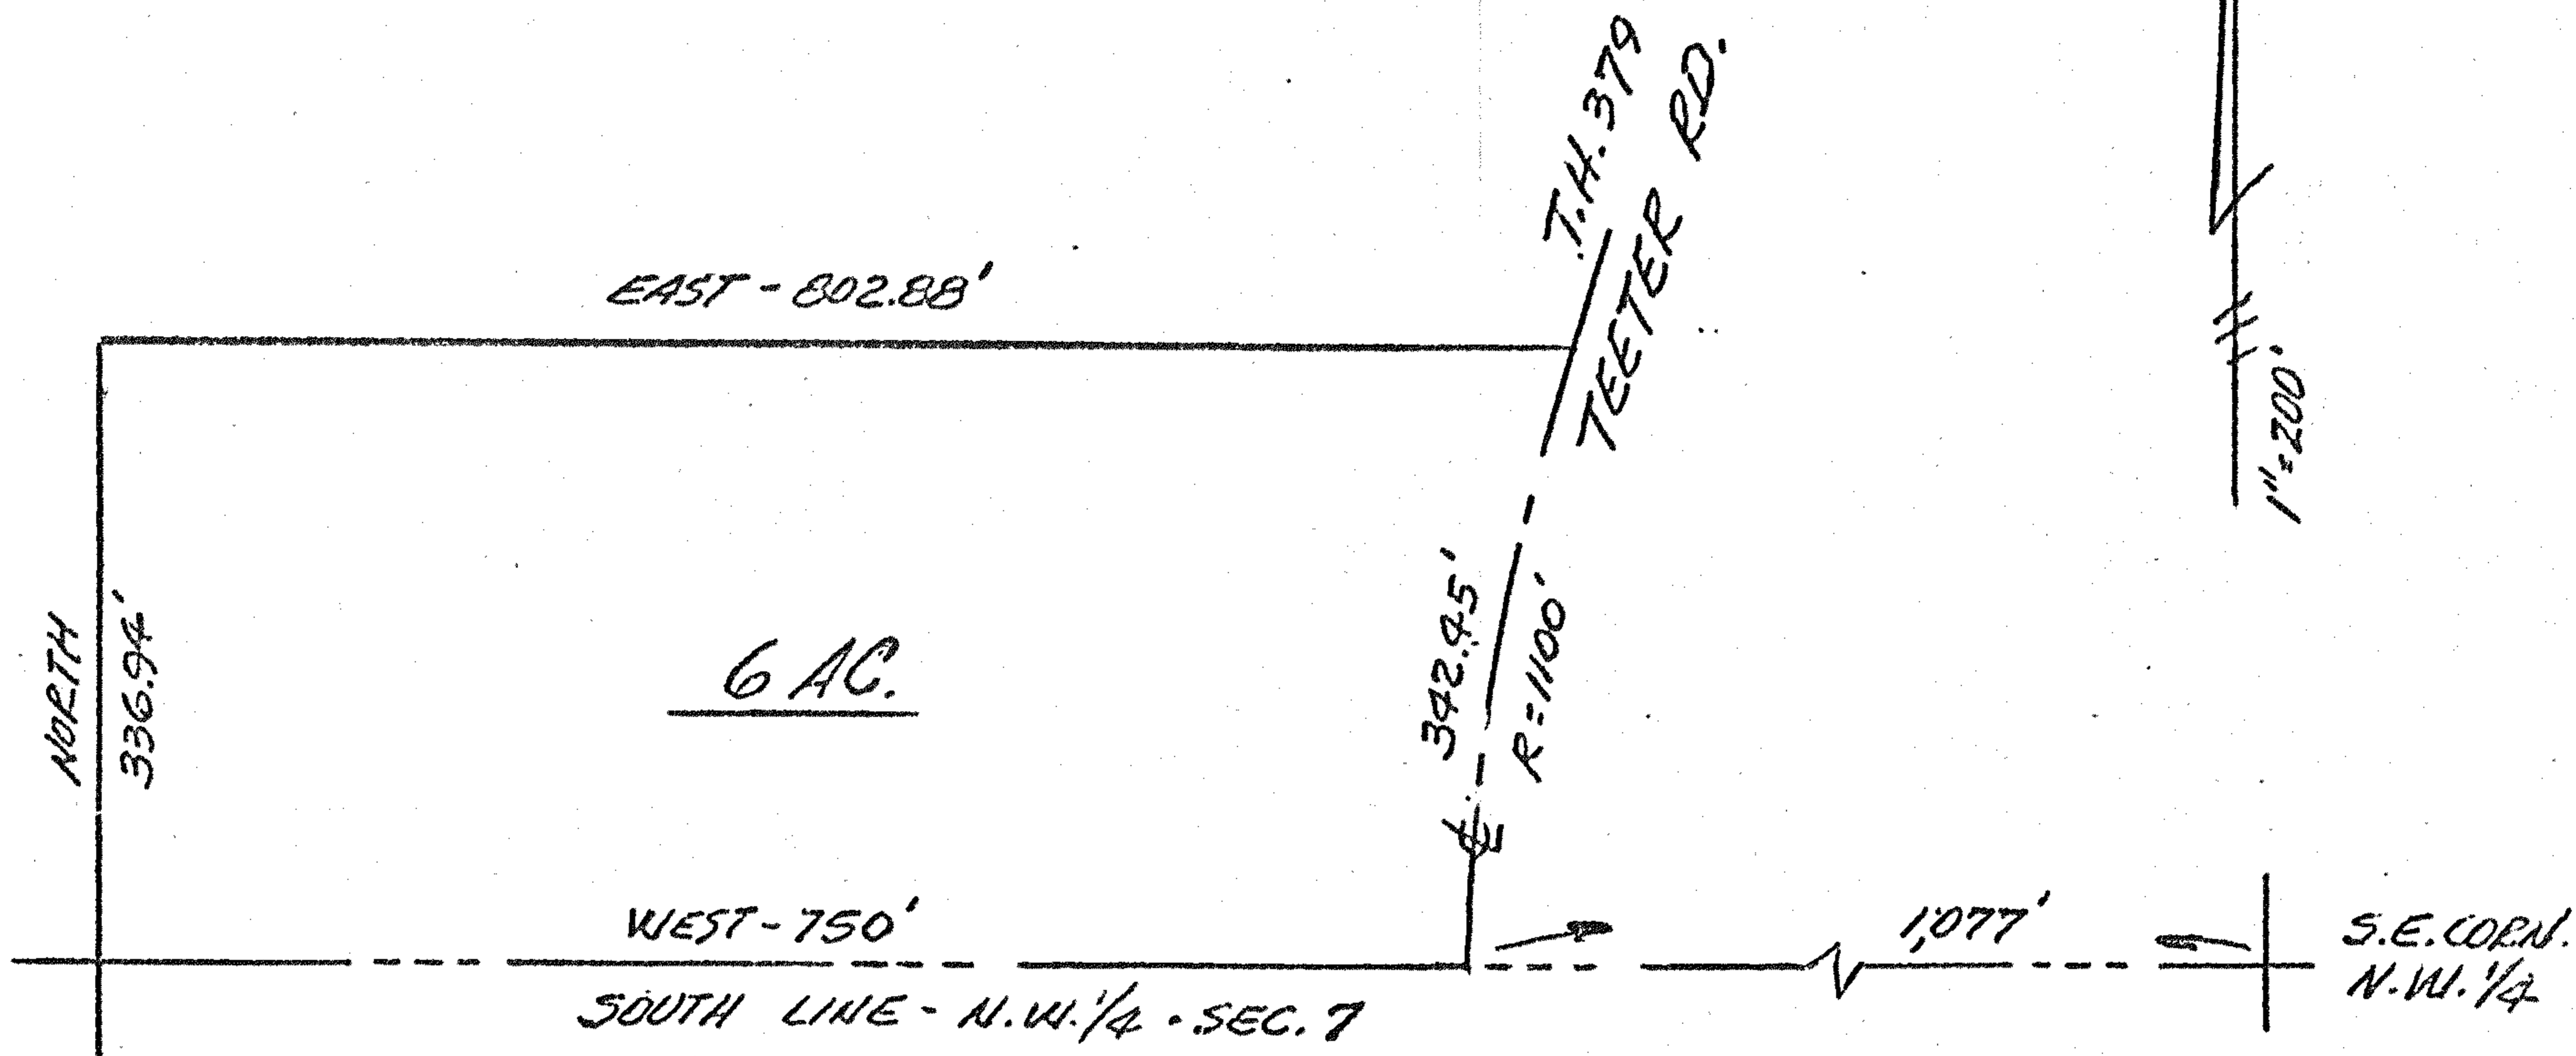
Situated in the Northwest quarter of Section 7, T.21, R.17 of Worthington Township, Richland County, Ohio and being further described as follows.

Commencing at the Southeast corner of said Northwest quarter; thence West, along the South line of the quarter, 1,077 feet to the centerline of Teeter Road, T.H. 379 and the true place of beginning.

Thence continuing West, along the South line of the quarter, 750 feet to the Southeast corner of the D. and E. Cleland property; thence North, along the East line of the Cleland property, 336.94 feet; thence East and parallel to the South line of the quarter, 802.88 feet to the centerline of Teeter Road; thence Southwesterly, along said centerline, on a curve to the left, with a radius of 1,100 feet, 342.45 feet to the place of beginning.

Containing 6.0 acres of land and being subject to all legal highways and easements of record.....
