ETHEL THROSA PROPERTY  
 SECTION 7 - WORTHINGTON TWP.  
 RICHLAND COUNTY, OHIO

**LEGAL DESCRIPTION: 18.3 ACRES**

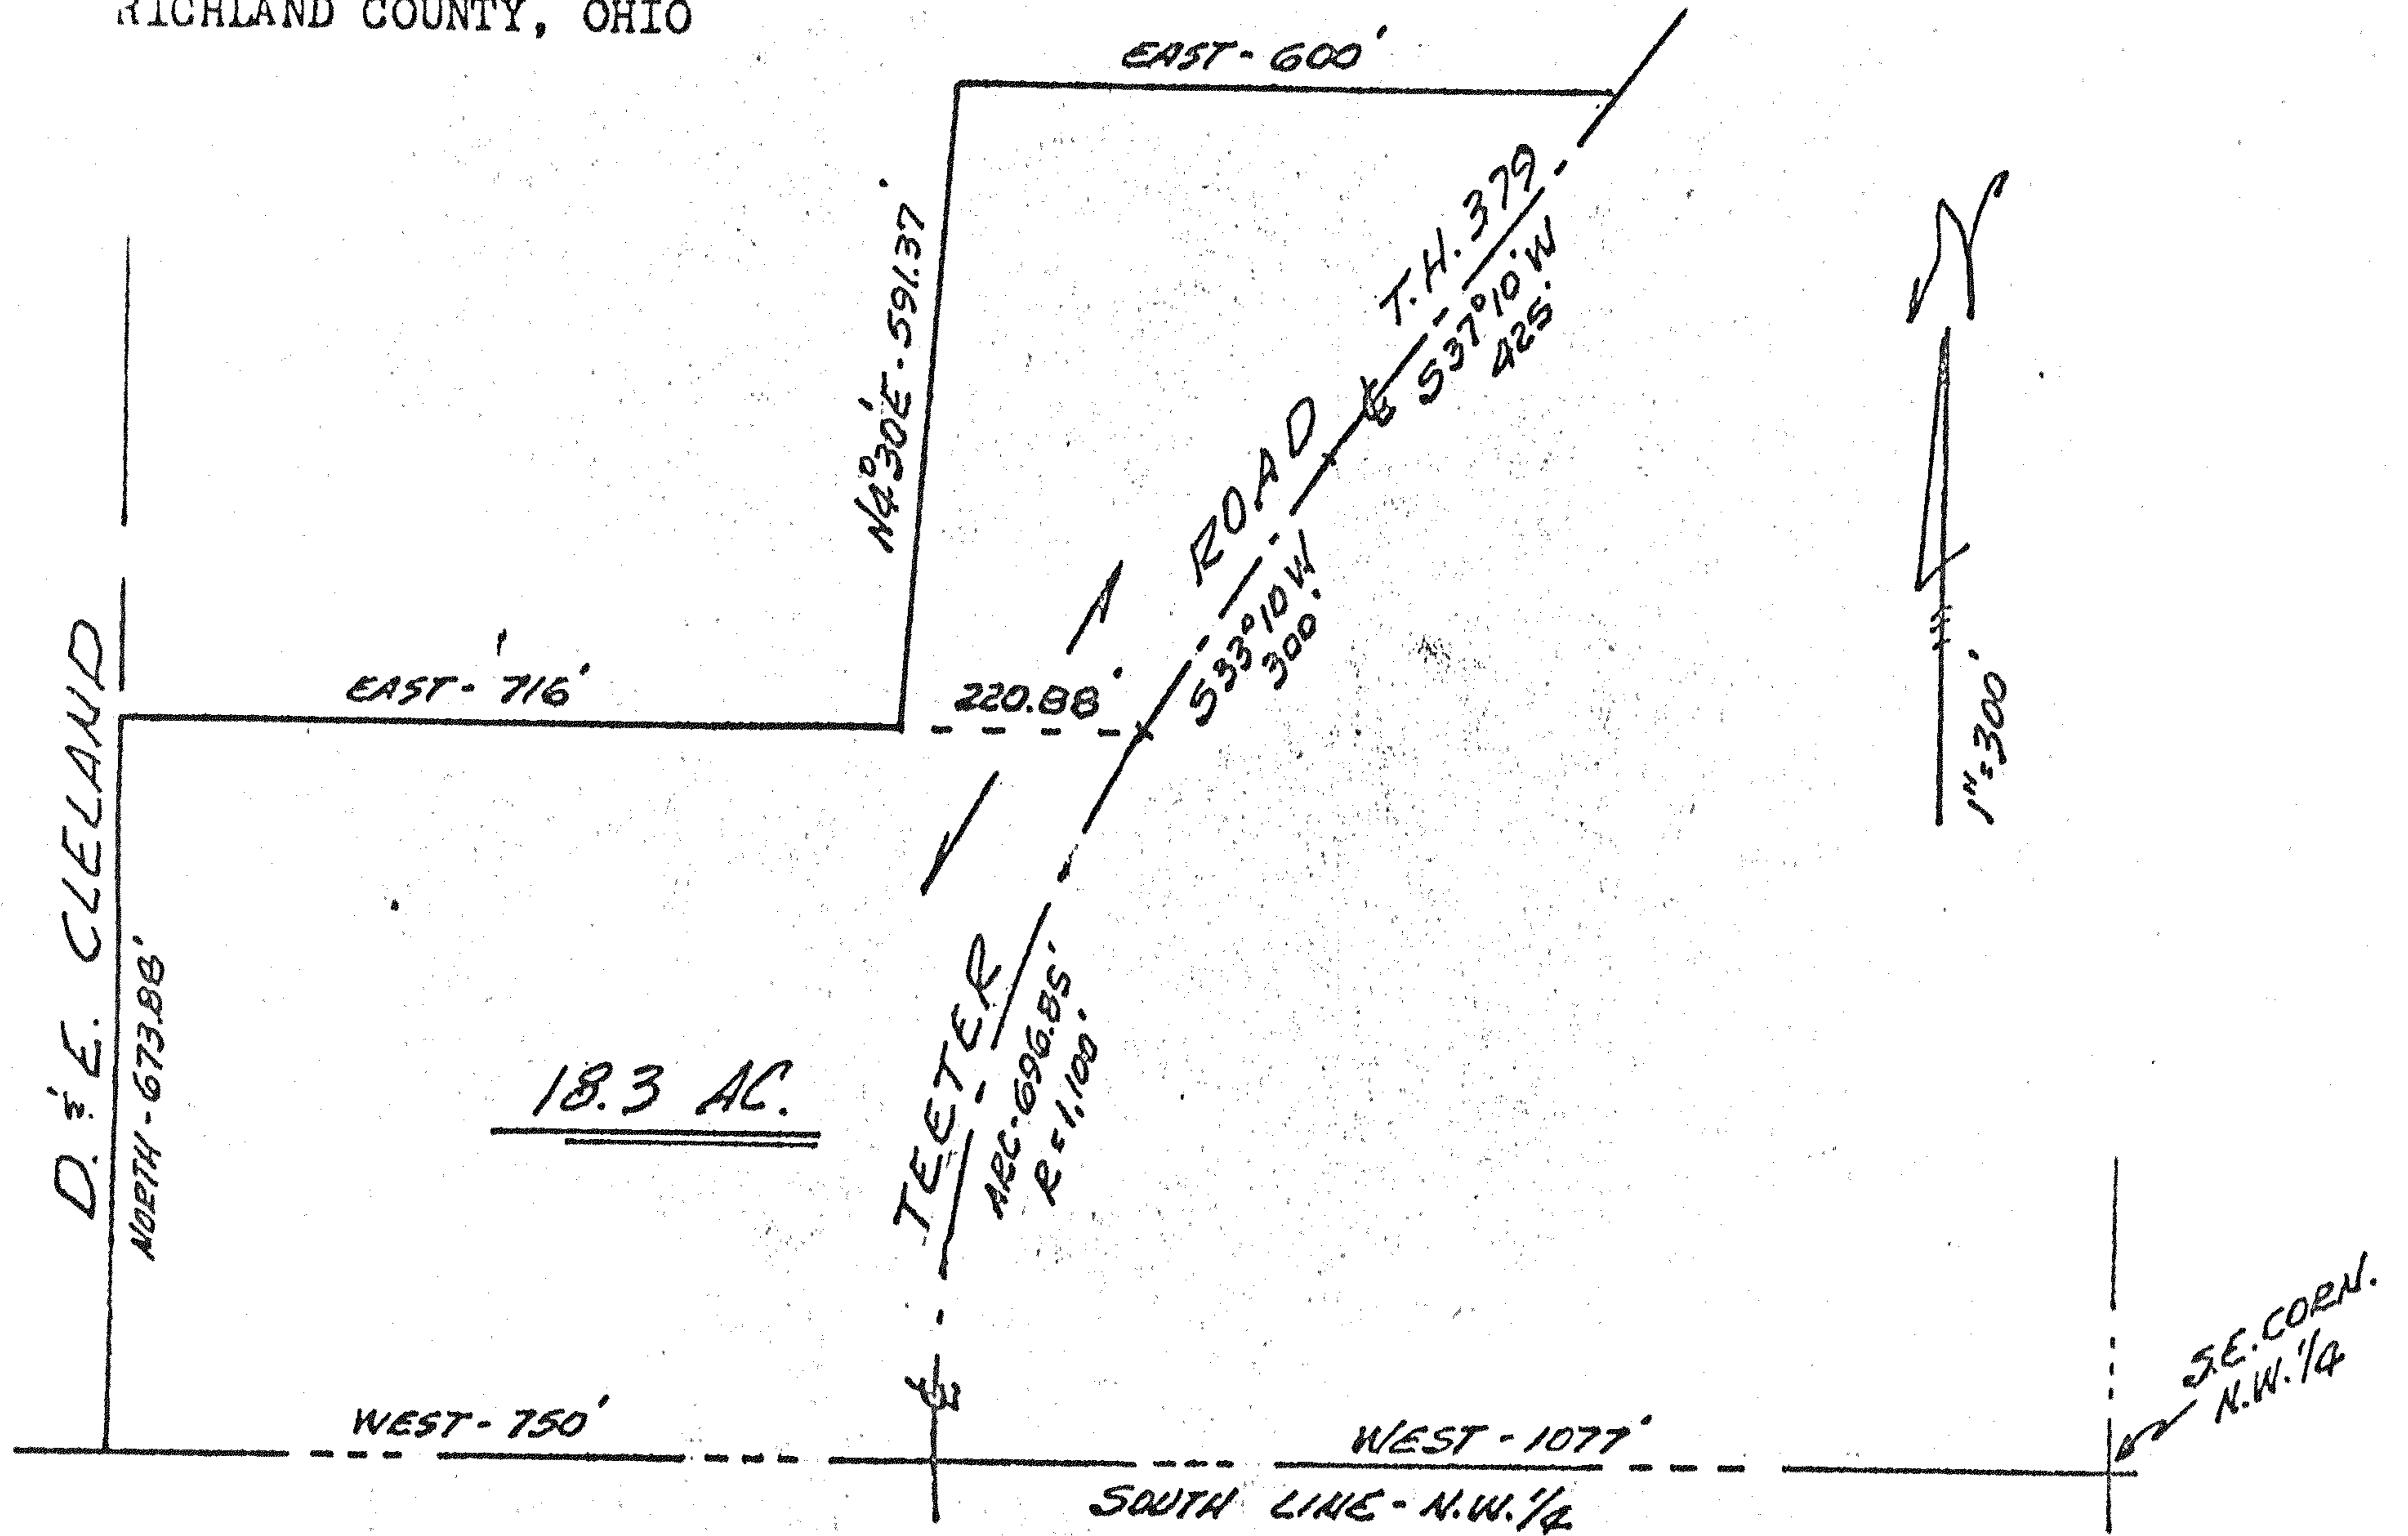
Situated in the Northwest quarter of Section 7, T.21, R.17 of Worthington Township, Richland County, Ohio and being further described as follows.

Commencing at the Southeast corner of said Northwest quarter; thence West, along the South line of the quarter, 1,077 feet to the centerline of Teeter Road, T.H. 379, and the true place of beginning.

Thence continuing West, along the South line of the quarter, 750 feet to the Southeast corner of the D. and E. Cleland property; thence North, along the East line of the Cleland property, 673.88 feet; thence East and parallel to the South line of the quarter, 716 feet to a point, said point being 220.88 feet West from the centerline of T.H. 379; thence N 4° 30' E, 591.37 feet; thence East and parallel to the South line of the quarter, 600 feet to the centerline of T.H. 379; thence S 37° 10' W, along said centerline, 425 feet; thence S 33° 10' W, along said centerline, 300 feet; thence Southwesterly, along said centerline, on a curve to the left, with a radius of 1,100 feet, 696.85 feet to the place of beginning.

Containing 18.3 acres of land and being subject to all legal highways and easements of record...
